International RILEM Conference on Materials, Systems and Structures in Civil Engineering 2016

## A CASE OF PEELING

Peeling of paint and plaster from building facades is a well-known phenomenon. This contribution analyses a case of peeling on a villa and its gardens walls, Figure 1. The walls were levelled with cement plaster, before painted with a formally very dense acrylic paint. - The analysis shows that the present layer of acryl paint is not very dense because it is applied on a rough plaster surface. - However, the main reason of the peeling seems to be the difference in thermal expansion between the masonry and the cement plaster. It is shown that the peeling takes place both winter and summer.

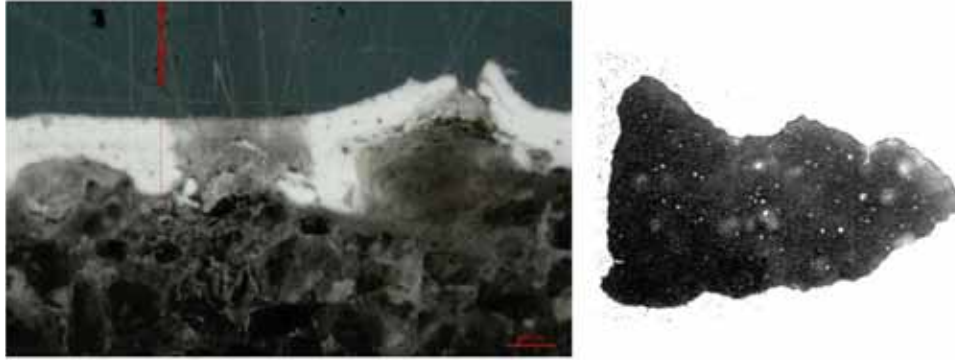
The specimens were examined on polished sections, Figure 2. The thickness of the inner layer were measured to 0,185 - 0,359 mm, and of the outer layer to 0,066 - 0,350 mm. Further it was observed that the paint contained inorganic material, probably kaolin.

Figure 2, left: Micro photo of cross section of the treatment on the south facade of the house. Lowest the cement plaster (grey and black), above the two white paint layers. The paint layer is broken over a protruding stone. The breath of the picture is equal to 2,5 mm. Photo DTI.  
 Figure 2, right: A piece of the paint layer in transmitted light. A lot of pinholes are seen. The breath of the picture is equal to 11 mm. Photo AN.

Firstly, the application to the rough surface of the cement plaster gives a paint layer, which in no way is “a homogeneous layer”. The paint film is punctured over the protruding sand particles from the plaster, because the capillary forces in the fluid paint draw the film away from the top of the particles, cf. Figure 2.

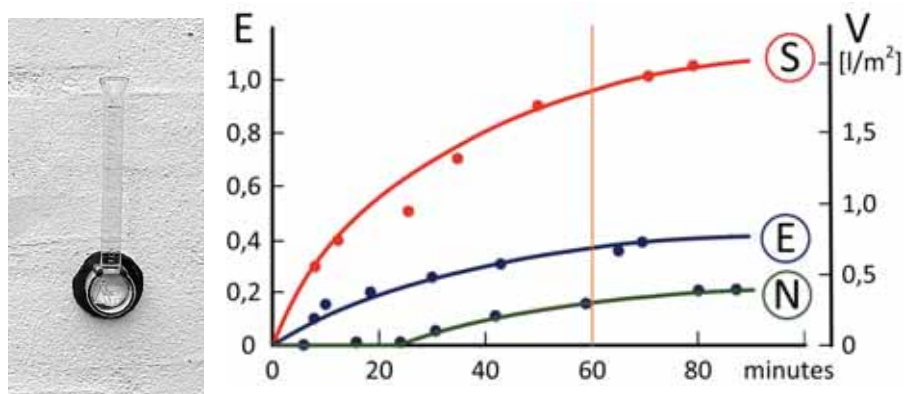
Figure 3. Karsten tube measurements. The glass tube at the device, left, is divided in units, E, which are transformed to suction,  $V \text{ l/m}^2$ . The height of the tube is 15 cm.

The capability of the surface treatment to suck up water was measured on three different walls by means of the so-called Karsten tube, cf. Figure 3. The measurements were taken in May 2015, i.e. four years after the painting. Measurement S was taken at the South faced façade, which is the most exposed. The suction here is around  $1,8 \text{ l/m}^2$  after 1 hour. Measurement E is from the East faced façade, which is less exposed. Here the suction is  $0,7 \text{ l/m}^2$  after 1 hour. Measurement N was taken on the North faced façade. Here it is seen that nothing happens in the first 24 minutes, hereafter the suction starts. This seems to correspond to the information about the high amount of kaolin in the paint: When the kaolin has expanded due to the water up-take, the paint layer has been opened so much that the water penetration can begin.

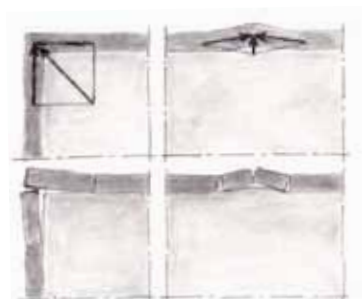
Figure 4. The compression forces in the surface layer cooperate at corners and unevenness's in resultants, which exceed the adhesion, thus causing peeling.

forces exceeding the adhesion; thus the plaster will peel of, cf. Figure 4. For this reason the peeling most often starts at the corners.

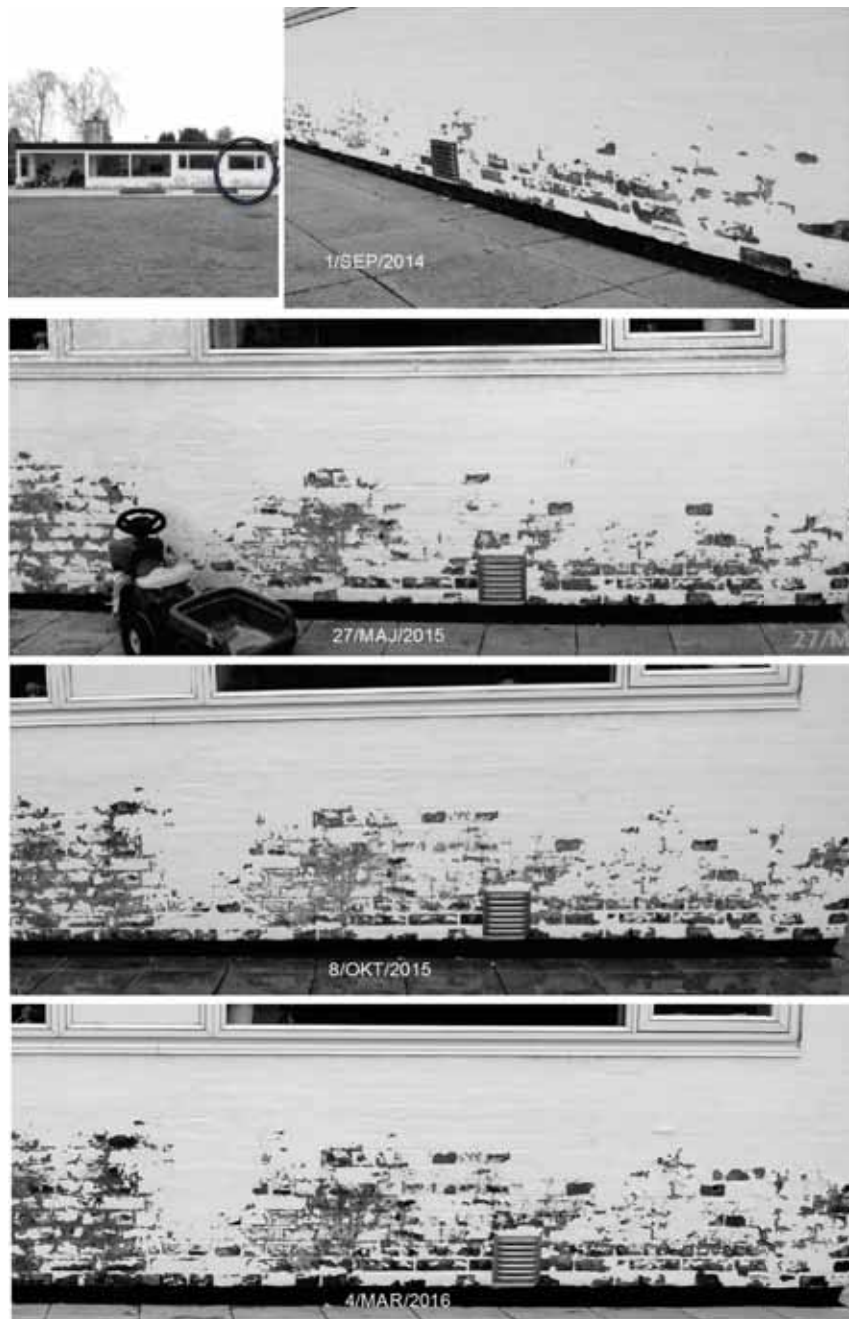
The damage does not start at day one. It is necessary with a number of temperature changes where small cracks are developed before the visible peeling starts. But first started, the phenomenon will occur all the year round, because temperature differences occur both summer and winter. This is in opposition to the generally accepted view that the peeling occurs in winter caused by freezing. The pictures on Figure 5 shows that the peeling takes place all the year round. The peeled-of pieces consist of plaster in the whole thickness, leaving the tile exposed.

Figure 5. Development of the peeling from September 1, 2014 to March 4, 2016.

- The correct repair in this case will be to remove all plaster and paint, and treat the walls with air lime mortar and lime wash, as should have been done from the beginning.
